Rock Plate™

Ceramic and Rubber Matrix Heavy Duty Linings

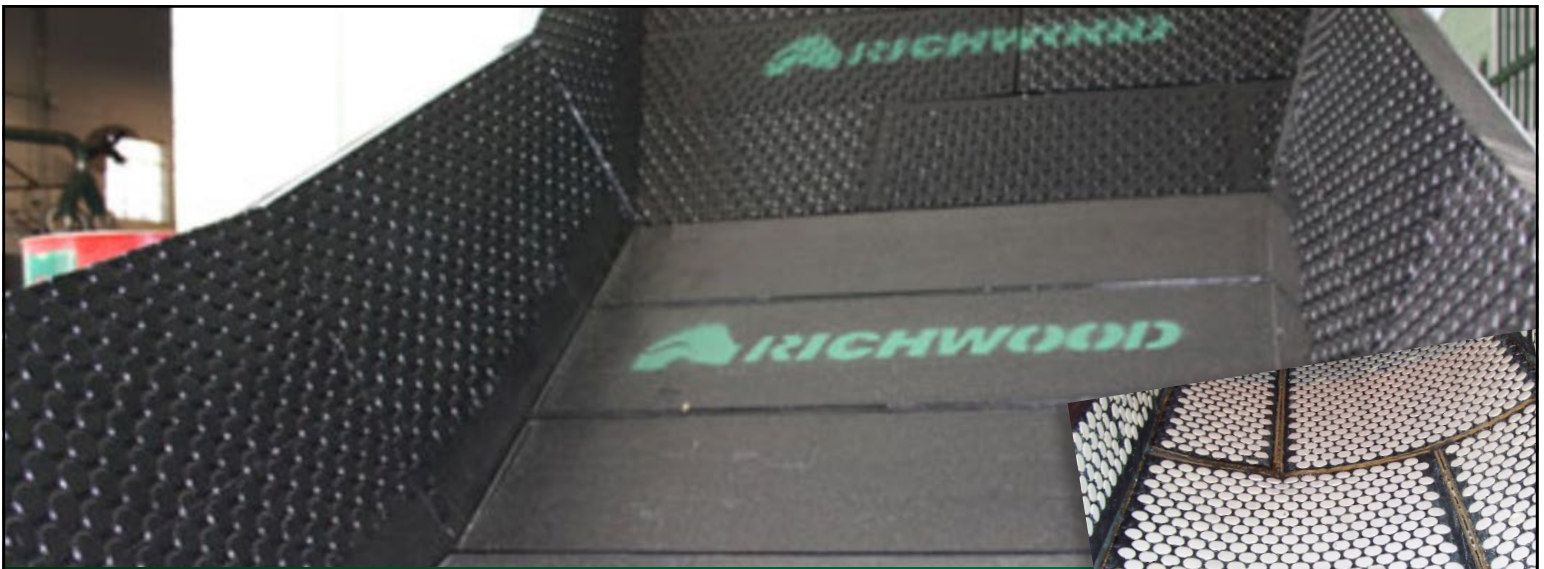
Rock Plate™ offers the solution with a combination of the proven wear resistance of high alumina ceramic and the impact absorbing properties of Richwood's Rock Flex® rubber. This combination allows the abrasion resistant ceramic to float in a bed of shock absorbing rubber, providing superior wear resistance and impact protection.

Supporting the abrasion resistant rubber/ceramic matrix is a base layer of R2000 rubber. This layer provides a high tensile cushion between the ceramic and the steel backing plate to diminish even the most abusive impact.
