Rubber/Ceramic Matrix Chute Liners

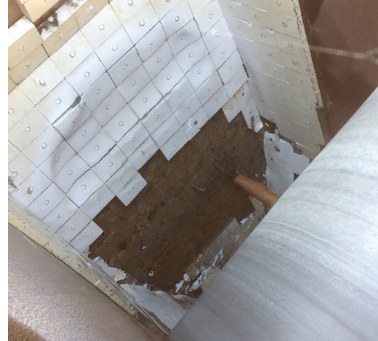
Application: Aggregates 3" minus granite.
BEFORE: Ceramic liner proved too brittle and material destroyed the liner and the metal chute wall. Replacement required hanging in plates, boom trucks, torches and welders.

Recommendation: Custom fit 12"x12" magnetic Rock Plate™ chute liners. Ceramic molded into rubber provides abrasion and impact resistance.

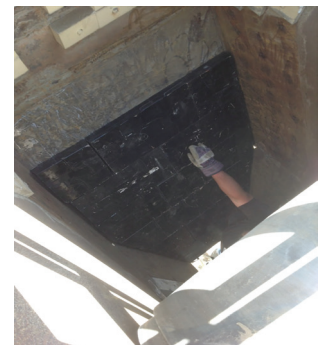
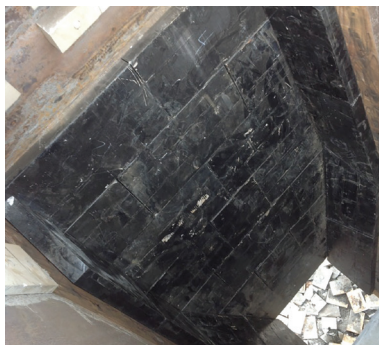
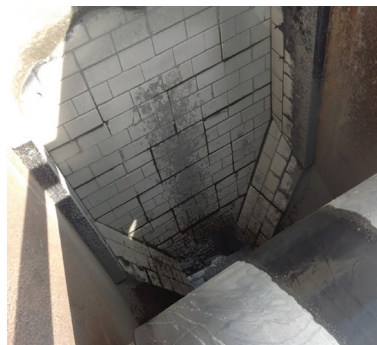
Result: Easier and safer installation, only worn pieces need replaced. Scheduling maintenance is simplified. Photo shown after three weeks run time.
