Material Containment Systems

How did an investment with Richwood save a company \$19K each month?

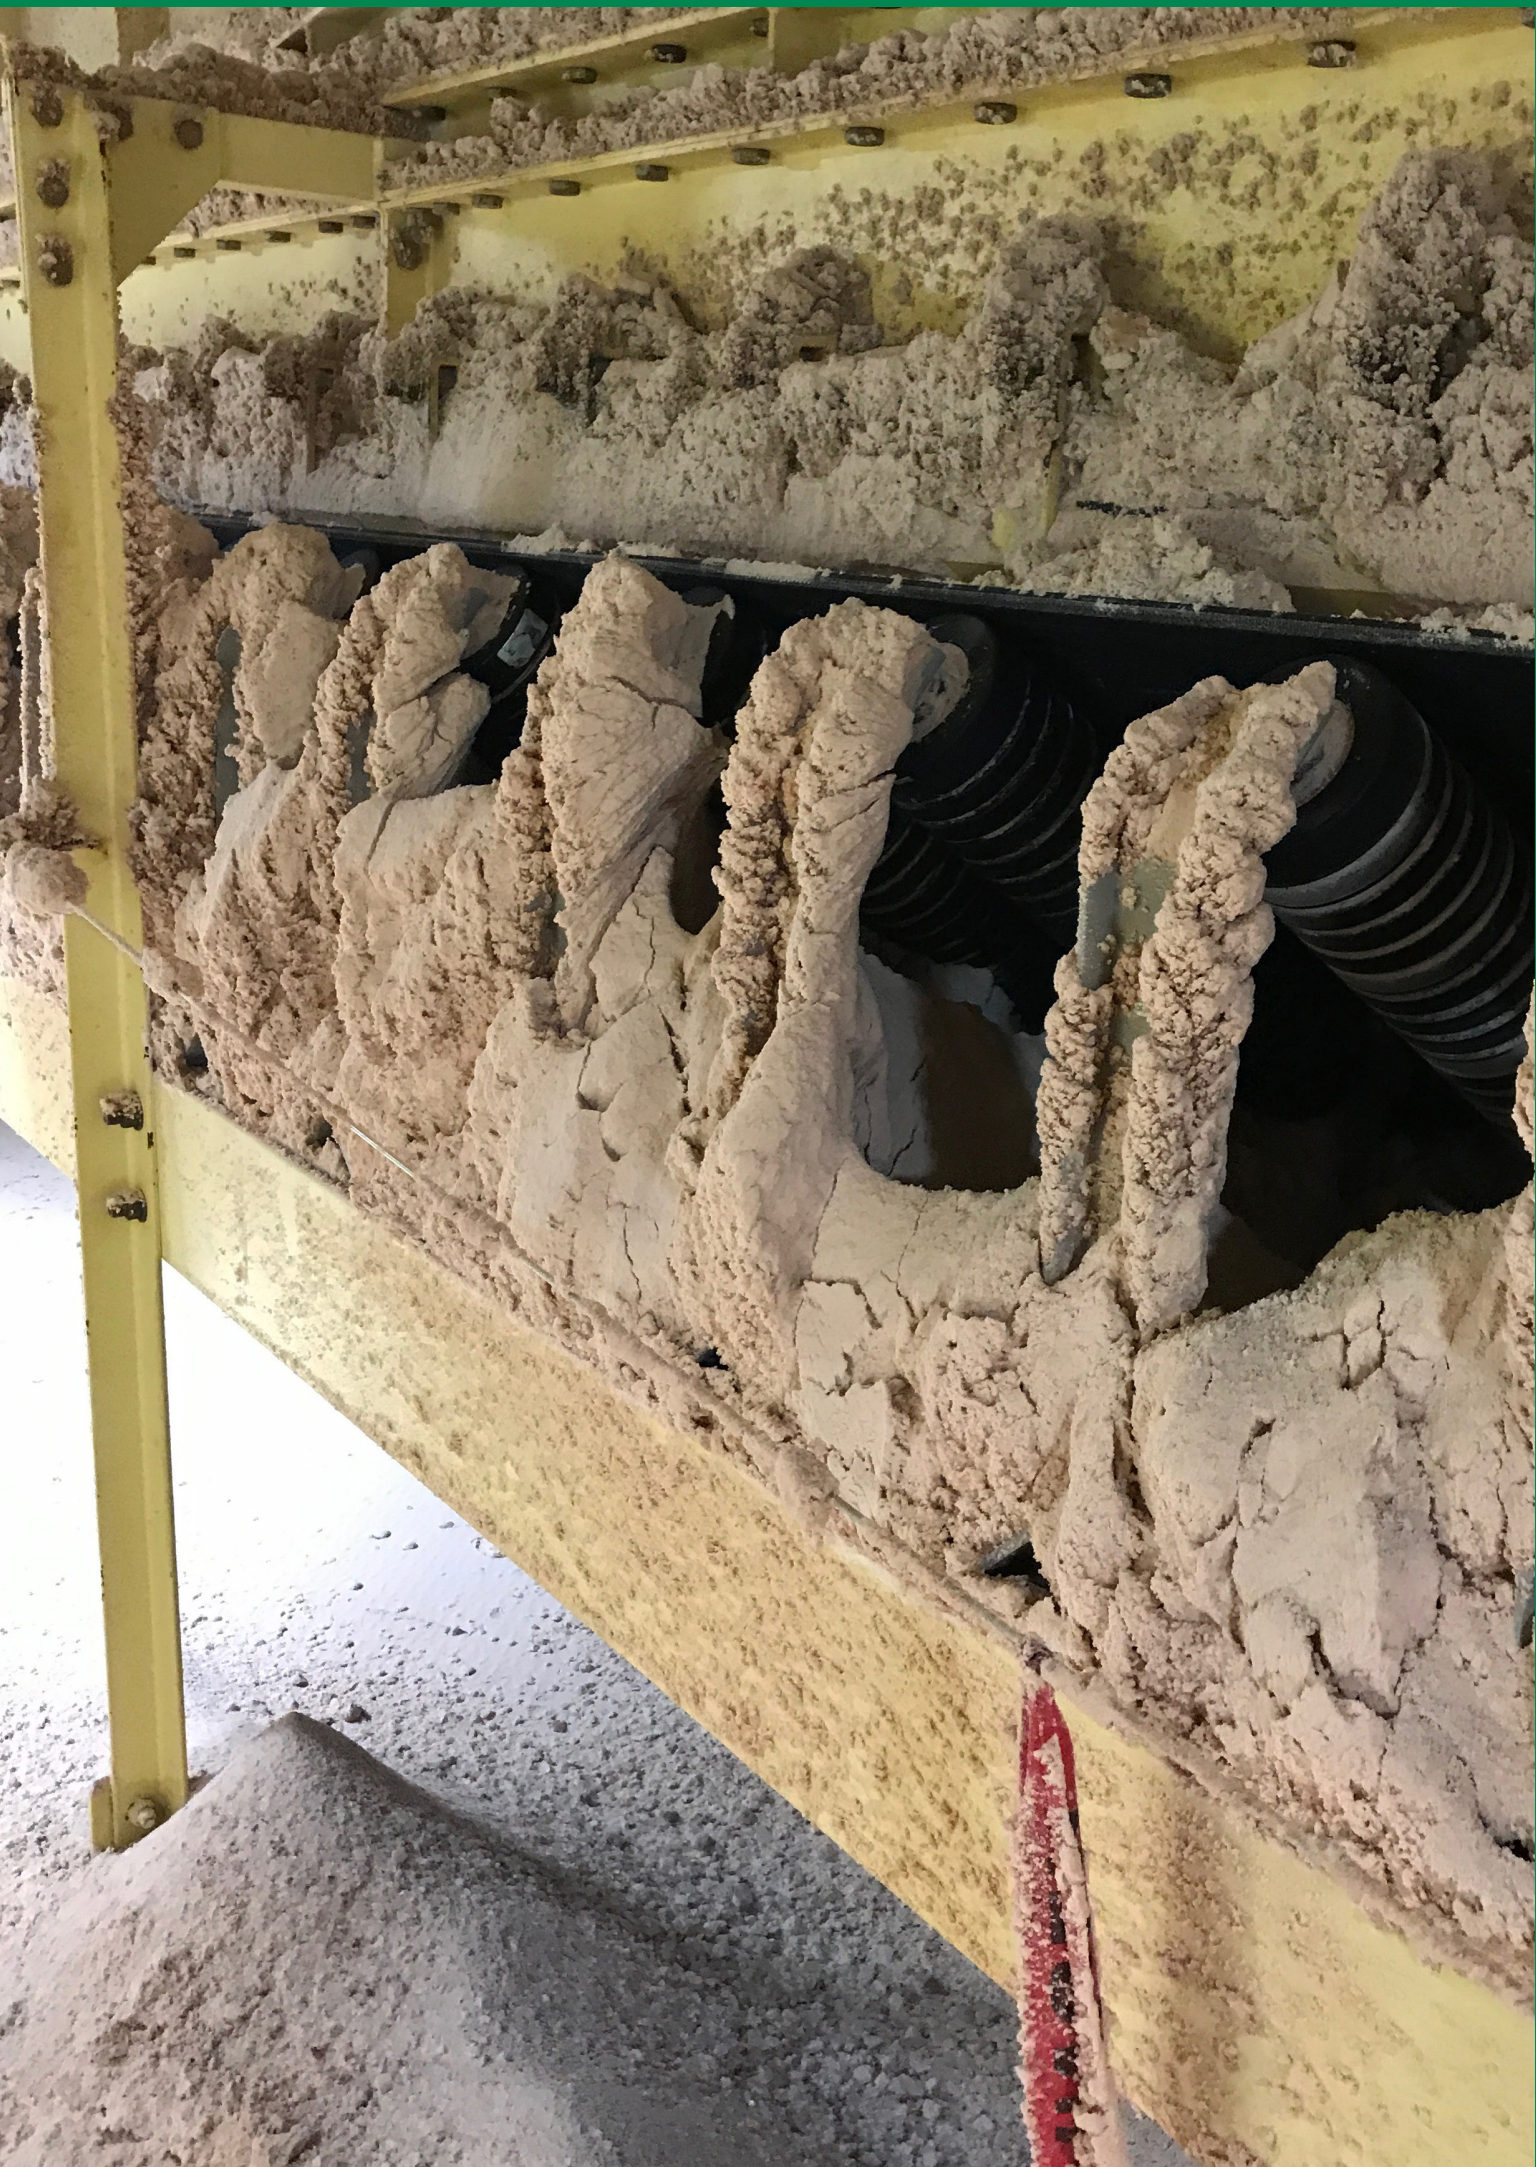
Before

In this potash facility, the area pictured was being cleaned with a water truck and employees in excess of 40 hours each week. A Richwood consultant recommended a new material containment system comprised of canoe liners, skirting with skirt clamps, impact saddles, cushion arc rollers and edge seal bar stands.

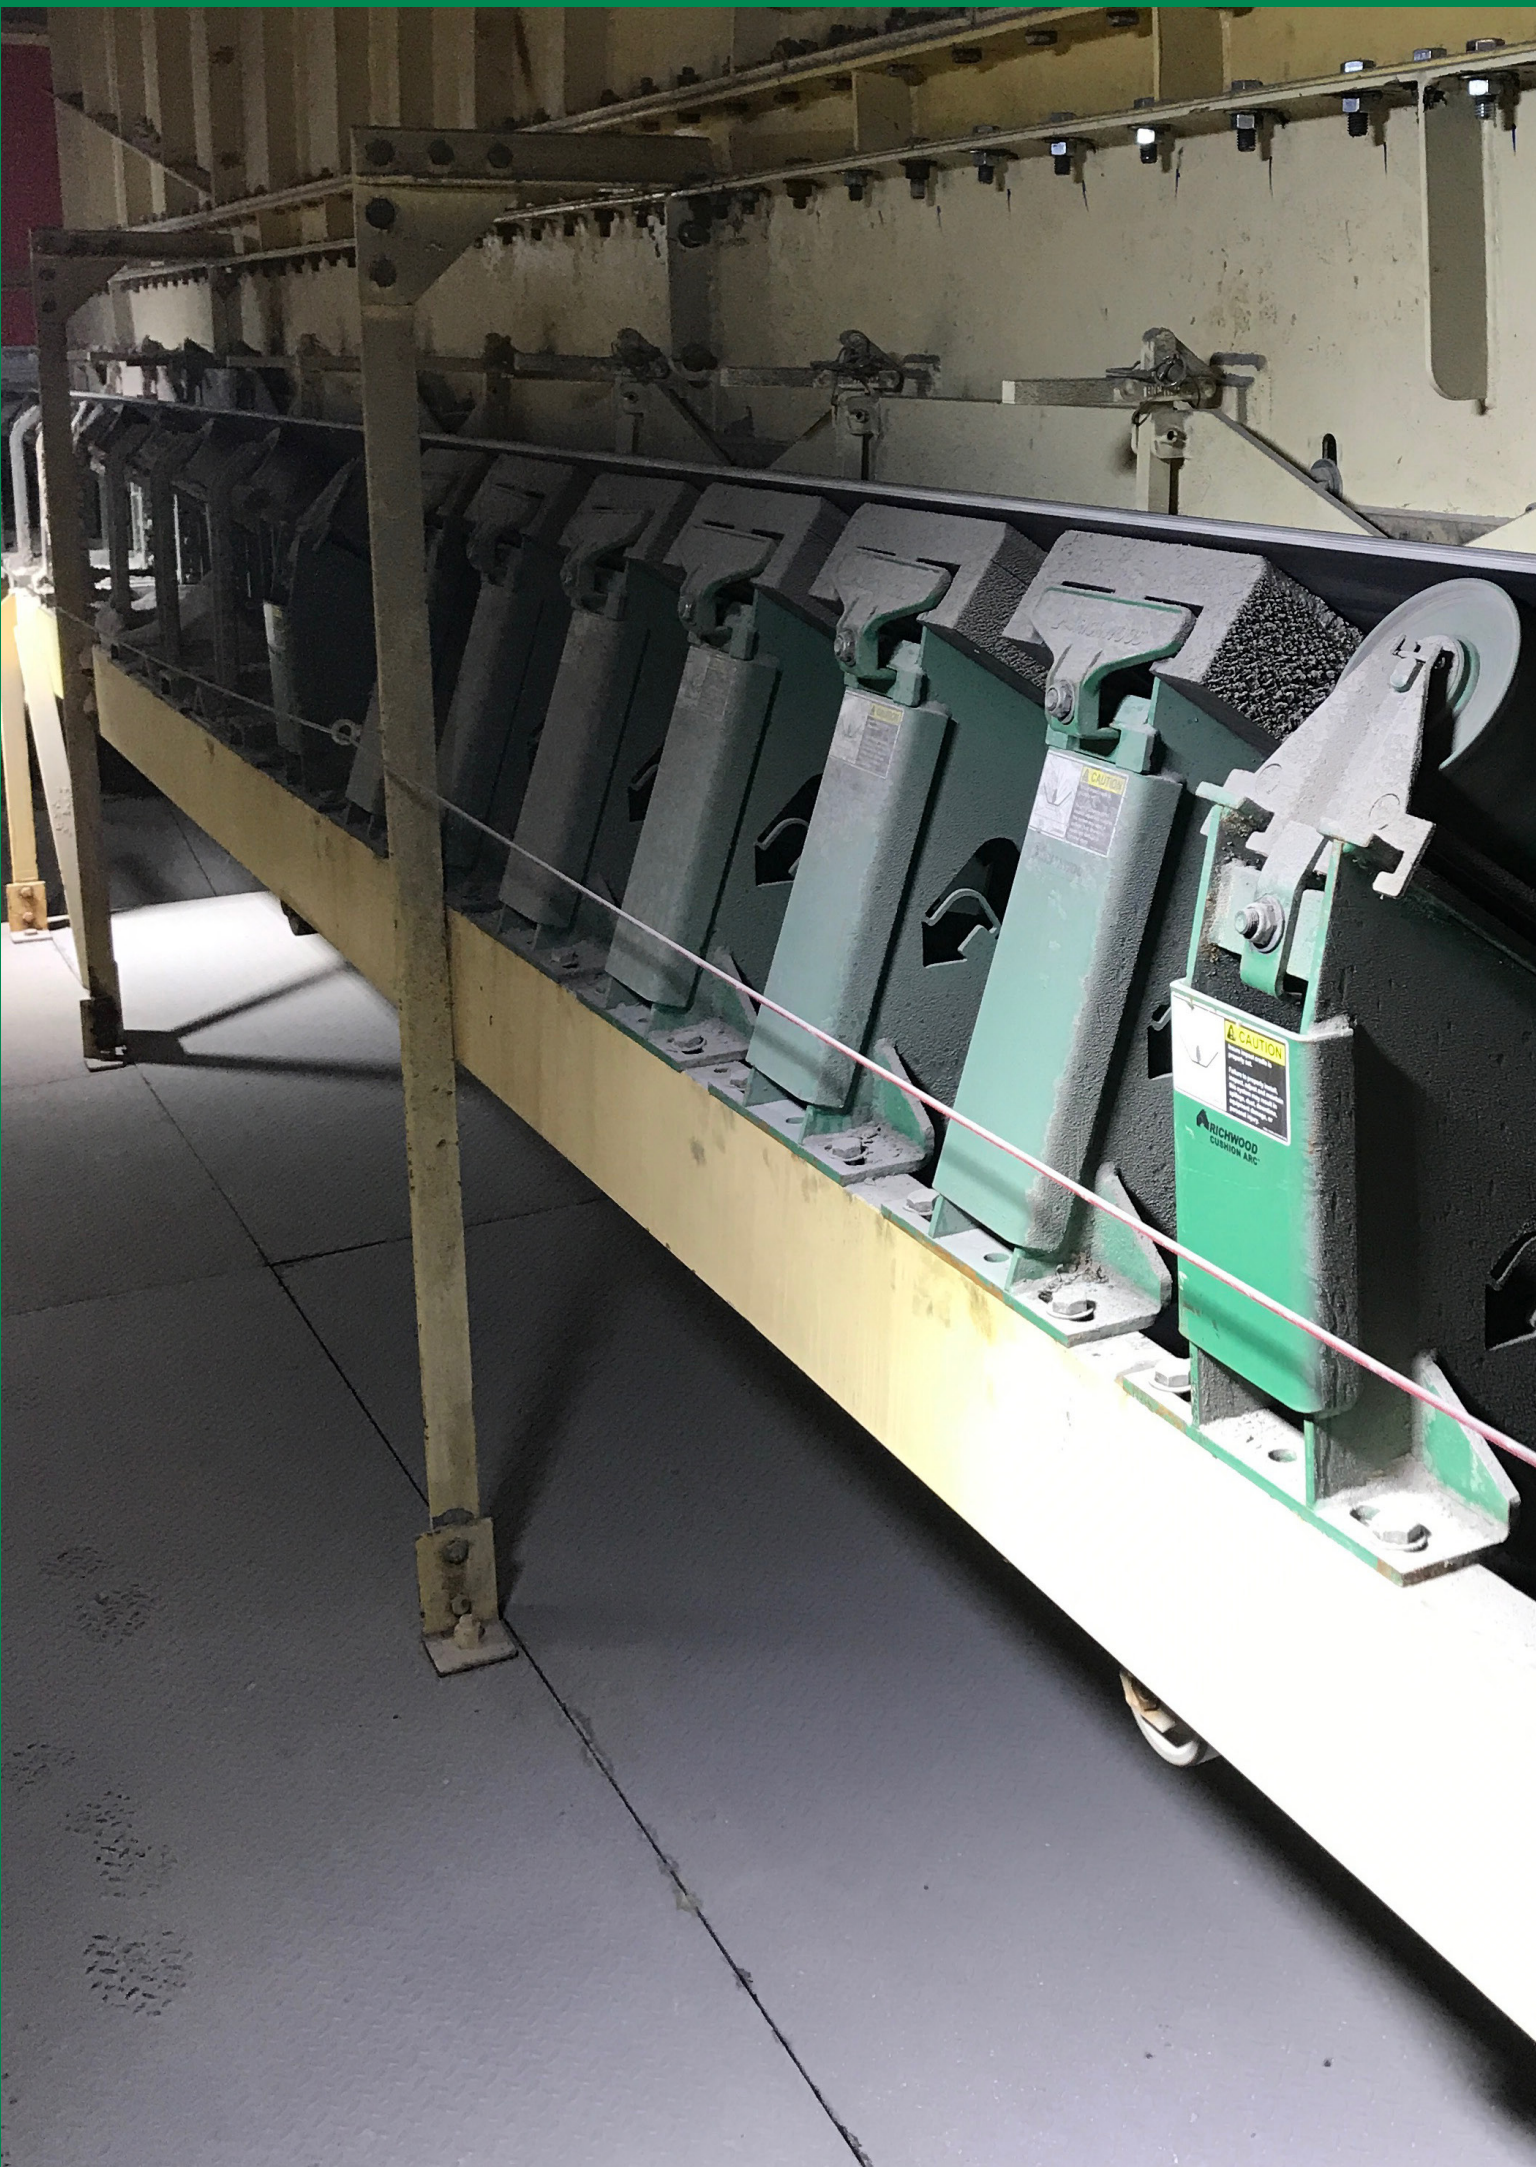
After

Cleaning time has been reduced to an average of 1-2 hours per month since the Richwood solution was applied.

The only reason any cleaning is necessary at all is due to fugitive dust that arrives out of the unsealed delivery system above.

The after photos were taken 10 days after the installation.
